## Workplace Health and Safety Queensland

## Asbestos bags recycled for use in carpet underlay

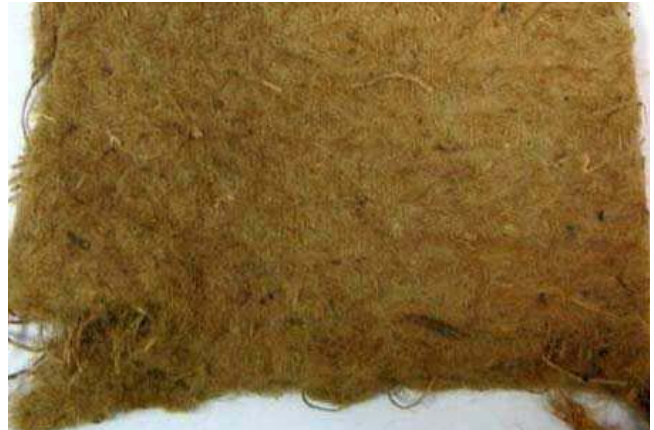
The exact characteristics of the suspect underlay are not fully known. However, it is likely to be brown in colour and look like a fibrous mat. It is also likely to be compacted as it has been under the carpet and walked on. In most cases the underlay was either glued on to a concrete floor or stapled on to a timber floor.

Photo 1: The suspect carpet underlay may look similar to this

Carpet underlay that contains asbestos fibres is to be regarded as a 'friable' asbestos containing material. This means that the asbestos fibres are in a loose form and if the underlay is disturbed, for example, for repairs or removal, asbestos fibres would become airborne and could be inhaled.

Carpets and carpet underlay laid prior to 1980 should be considered suspect. No repairs or removal work can commence until the underlay is inspected.

If the underlay is an asbestos containing material, removal of the underlay and the carpet must only be carried out by an 'A class' asbestos removal certificate holder and performed in accordance with the national *Code of Practice for the Safe Removal of Asbestos* 2nd ed. [NOHSC:2002(2005)]. 'A class' asbestos removal certificates are issued by Workplace Health and Safety Queensland.

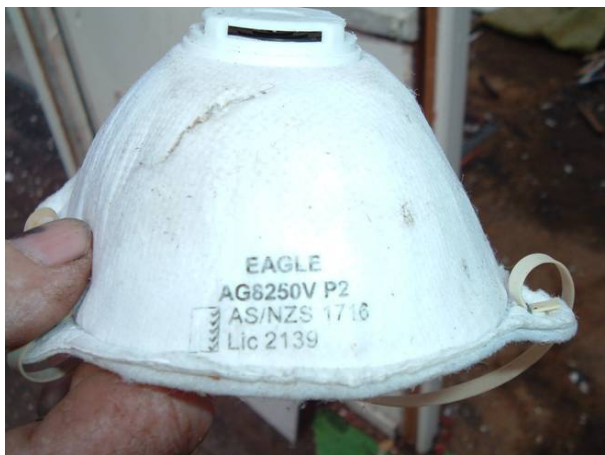
Photo 2: Check face mask label

Suspect carpet underlay can be inspected safely. A 'Class P2' face mask (not a dust mask) must be worn at all times when the underlay is being inspected. Single-use P2 masks are available from safety equipment stores and some hardware stores. They will state 'P2' and AS/NZS 1716 somewhere on the mask.
