Is it safe? Cracked, damaged or weathered asbestos cement sheeting

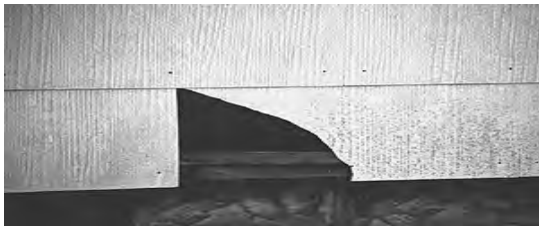
Cracked or Damaged Sheeting

At the time asbestos cement sheeting is cracked or damaged, some respirable asbestos fibres can be released into the air.

However, the number of released fibres is likely to be very low. This is because the material is not 100% asbestos, asbestos fibres in the sheeting are predominantly large and the asbestos is bound into the cement.

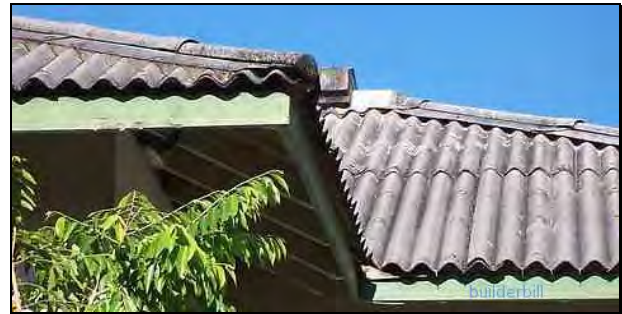
After it is damaged, asbestos cement sheeting does not continue to release significant quantities of asbestos fibres into the air. This is because the asbestos continues to be bound in the cement. To protect exposed edges from ongoing damage, they can be painted or sealed.
