Asbestos bags recycled for use in carpet

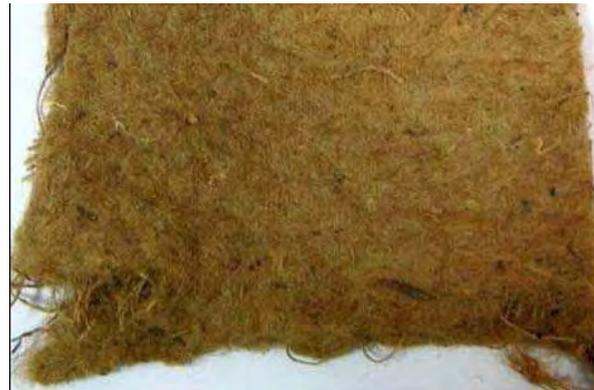
The exact characteristics of the suspect underlay are not fully known. However, it is likely to be brown in colour and look like a fibrous mat (see right). It is also likely to be compacted as it has been under the carpet and walked on. In most cases, the underlay was either glued on to a concrete floor or stapled on to a timber floor.

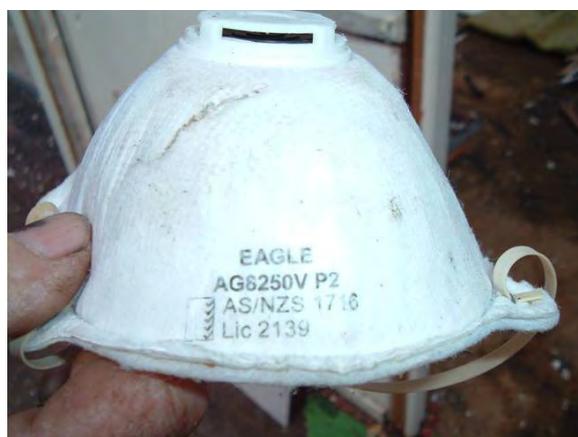
You can safely inspect your carpet for the suspect underlay. You should wear a "Class P2" face mask (not a dust mask) at all times when undertaking this task (see right). Single-use P2 masks are available from safety equipment stores and some hardware stores. They will state "P2" and "AS/NZS 1716" on the mask.
