Workplace Health and Safety Queensland

Asbestos flooring

This fact sheet provides information regarding asbestos backed vinyl sheet flooring and vinyl tiles containing asbestos.

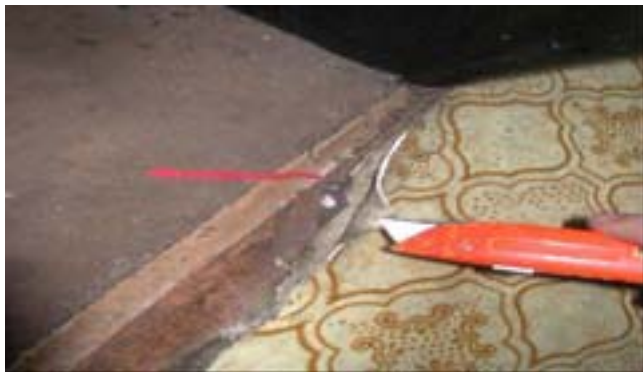
Asbestos backed vinyl sheet flooring is where the 'backing' (the side attached to the floor— see Figure 1) contains friable (easily broken) asbestos material.

Figure 1 – Asbestos backed vinyl sheet flooring

The vinyl sheeting itself does not contain asbestos, however, manufacturers sometimes incorporated a felt-like 'backing' for cushioning purposes. It is this backing which contains asbestos (typically 80–100 per cent).

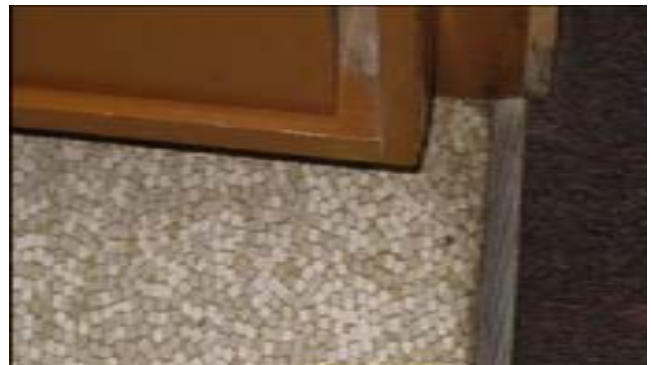
Usually applied in sheet form, a lot of asbestos backed vinyl sheet flooring had a 'terrazzo' type (colourful marble or stone chip – see Figure 2) pattern on the surface. It is most commonly found in buildings constructed before the mid-1980s.

Figure 2 – Terazzo type asbestos backed vinyl sheet flooring.

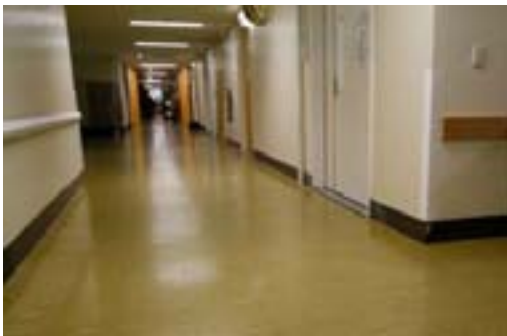
Asbestos vinyl tiles contain 8–30 per cent asbestos in a tightly bonded matrix (see Figure 3). They do

not have a 'backing' and are usually glued directly to the floor. It should be noted that glue used to adhere the asbestos vinyl tiles to the floor may also contain asbestos.

Figure 3 – Asbestos vinyl tiles © WorkSafe Victoria
