Workplace Health and Safety Queensland

Asbestos – Low density asbestos fibre board

Asbestos – Low density asbestos fibre board
PN10005 Version 2. Last updated November 2009.

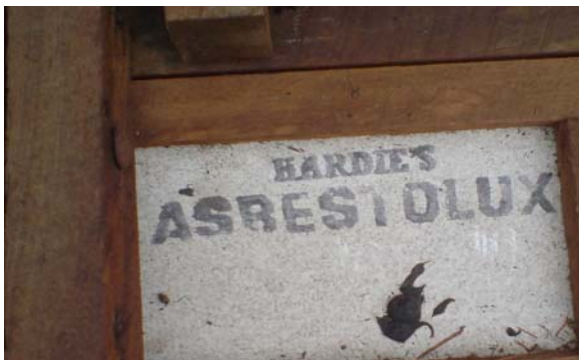
Photograph 1: Asbestolux

Low density asbestos fibre board is a lightly compressed board which looks similar to asbestos cement sheeting or plaster board. It is also sometimes referred to as asbestos insulating board. Generally, low density asbestos fibre board was manufactured as a flat sheet product although some perforated sheeting typically used for acoustic ceiling applications was also manufactured. The most common example of low density asbestos fibre board is 'Asbestolux', a product formerly manufactured by James Hardie Pty Ltd.

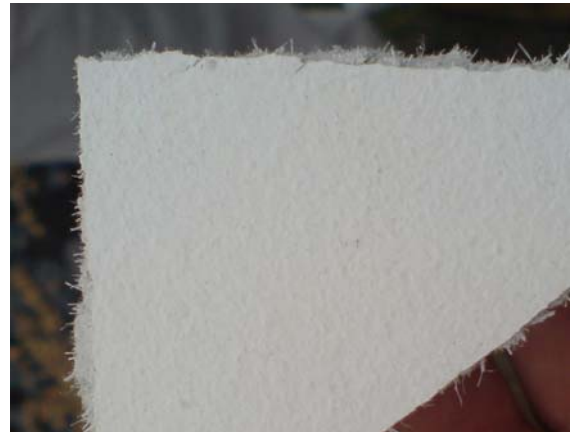
Photograph 2: Low density asbestos fibre board

Samples of low density asbestos fibre board have shown it contains up to 70 per cent (by volume) asbestos fibres and is generally composed of brown asbestos (amosite) and white asbestos (chrysotile) in a calcium silicate plaster. The asbestos fibres are not bound in a cement matrix as with asbestos cement sheeting.

Low density asbestos fibre board is often soft and the pressure of a fingernail pushed into the surface can leave an indentation.
