## Workplace Health and Safety Queensland

## SAFETY ALERT

### Capstan and windlass style winches

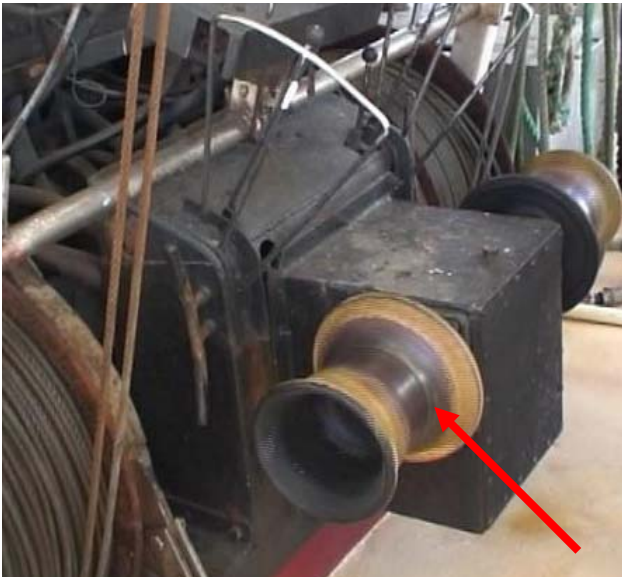
**Photograph 1** – Example of an unguarded windlass style winch

Commonly referred to in the commercial fishing industry as a capstan winch (similar to windlass except mounted on a vertical axis), windlass style winches (mounted on a horizontal axis as shown above in photograph 1) are basically defined as a device for raising weights (e.g. anchors) upon which a cable or the like winds. In this instance the winches are designed and used to wind in large lengths of cables.

- Engineering controls - obligation holders should consider:
  - installing appropriate guarding to prevent the risk of workers being caught in any of the moving parts
  - replacing the capstan or windlass style winch at deck level with a substitute plant item on the gantry level of the vessel to minimise human interaction
  - installing emergency stop buttons on or near the winch to immediately disengage the rotating parts.

- Administrative controls should include:
  - training and information based on the manufacturer's guidelines for safe operating procedures
  - consideration regarding the type of clothing worn when operating or working near these types of winches (e.g. wearing close fitting jackets with elasticised waist and sleeve cuffs to prevent entanglement).
